Pressure System Safety

1971 Bldg. 64 Explosion

Vincent Verhoff
GRC Pressure Systems Manager (PSM)

June 22, 2005

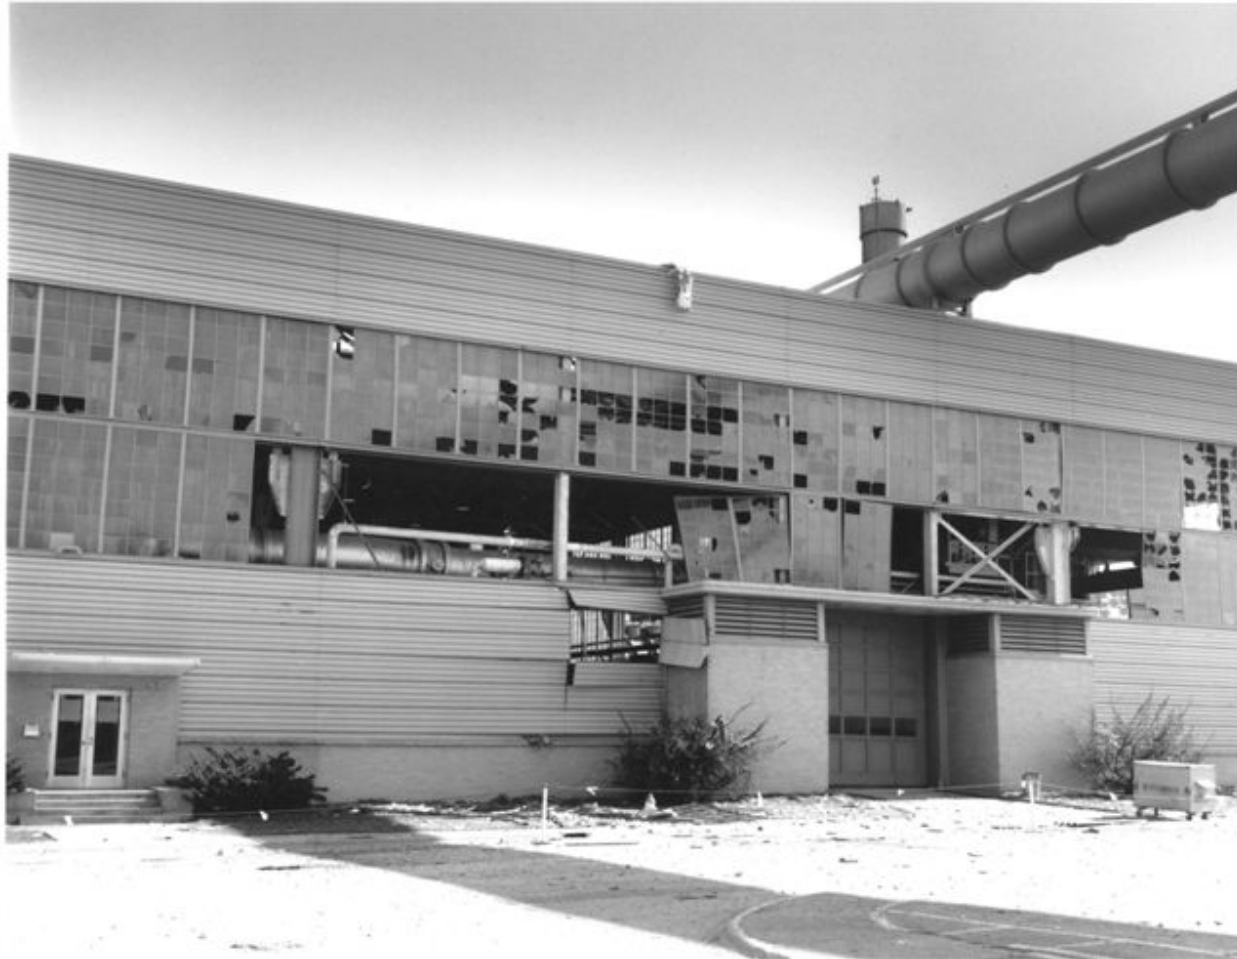
Outside of Building 64

The hole in the roof was approximately 30 feet in diameter. Approximately 60% of the large window area on two sides of the building near the explosion was destroyed. Two men, approximately 150 feet outside the building, were struck by falling debris. One man suffered a fracture near the right elbow. The other man was uninjured. The explosion caused extensive damage to piping, expansion joints, tie rods, supports, and other equipment in the vicinity.

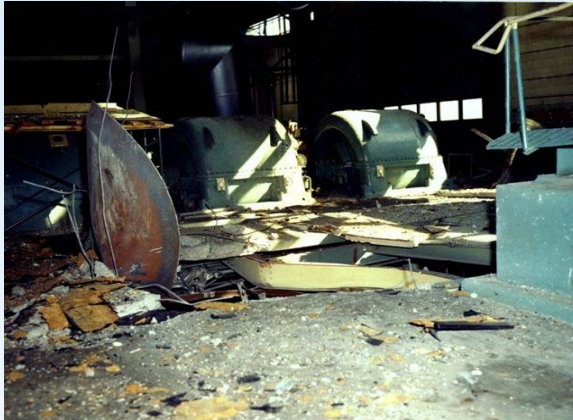
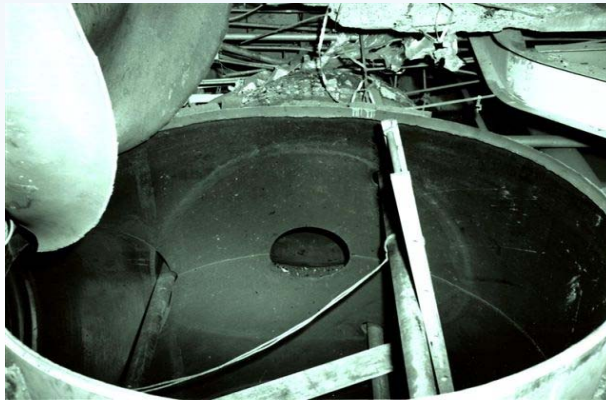
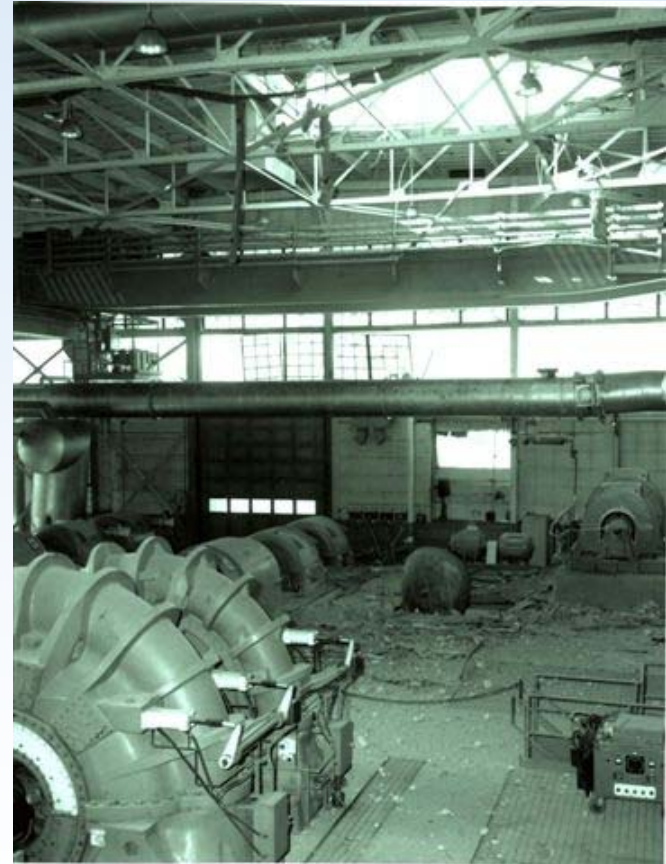
Inside of Building 64

At 12:15 a.m., April 7, 1971, an overpressure occurred in the Altitude Exhaust System in the basement of Building 64, which resulted in the catastrophic rupture of a 96" inverted dished head. The resulting release of pressure caused complete fragmentation of a 6-inch reinforced concrete floor directly above the dished head. I-beams under the concrete floor were extensively distorted and damaged. A hole was blown in the roof approximately 35 feet above the floor level.
