SPACE SIMULATION AND FULL-SCALE TESTING IN A CONVERTED FACILITY

By John H. Povolny

Lewis Research Center

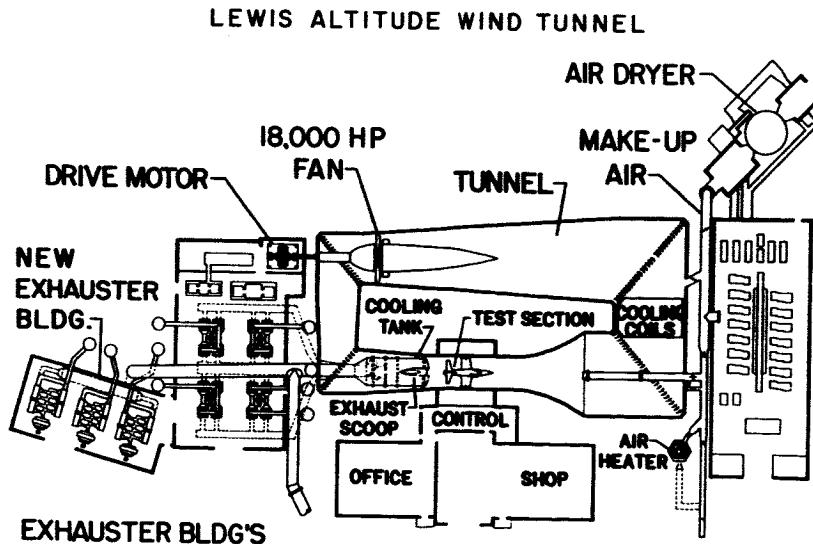
Figure 1.

The Space Simulation Chamber described in this paper was converted from a former wind tunnel complex (fig. 1). Conversion consisted of removal of the turning vanes, cooling coils, and circulation fan and the addition of three bulkheads. The large chamber is approximately 60 feet in diameter with a volume of 250 000 cubic feet and is utilized for tests to altitudes of 100 000 feet. The second, smaller chamber, and the one of interest, is approximately 30 feet in diameter and 100 feet long and has a volume of 70 000 cubic feet. A $22\frac{1}{2}$ -foot extension was added to provide a total height of 45 feet in order to accommodate the Centaur test vehicle. Present vacuum pumping capability is 2×10^{-6} millimeter of mercury, and with the Centaur test vehicle installed an ultimate of 2×10^{-5} millimeter of mercury is attained. Figures 2 to 5 show various views of the Space Simulation Chamber (SSC) and the installation of the Centaur vehicle.

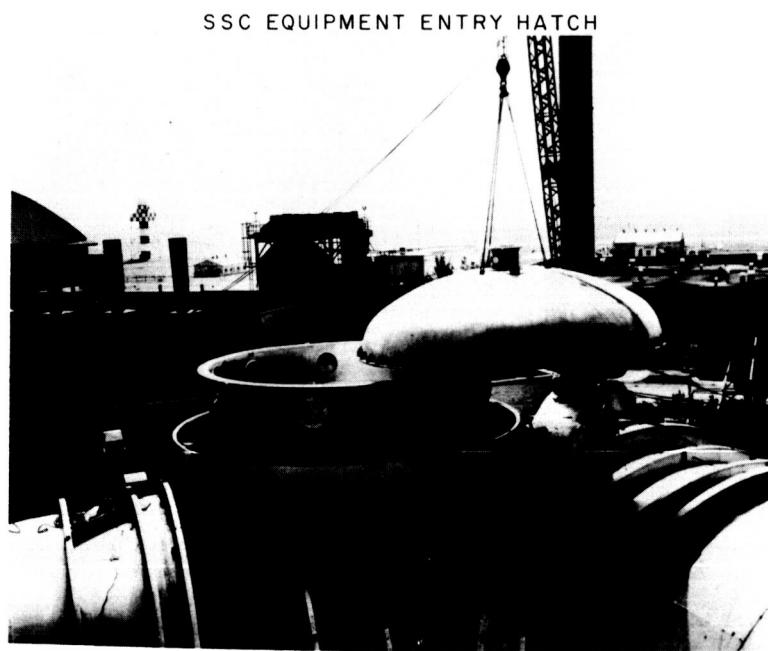
Figure 3

LOWERING OF CENTAUR INTO SSC

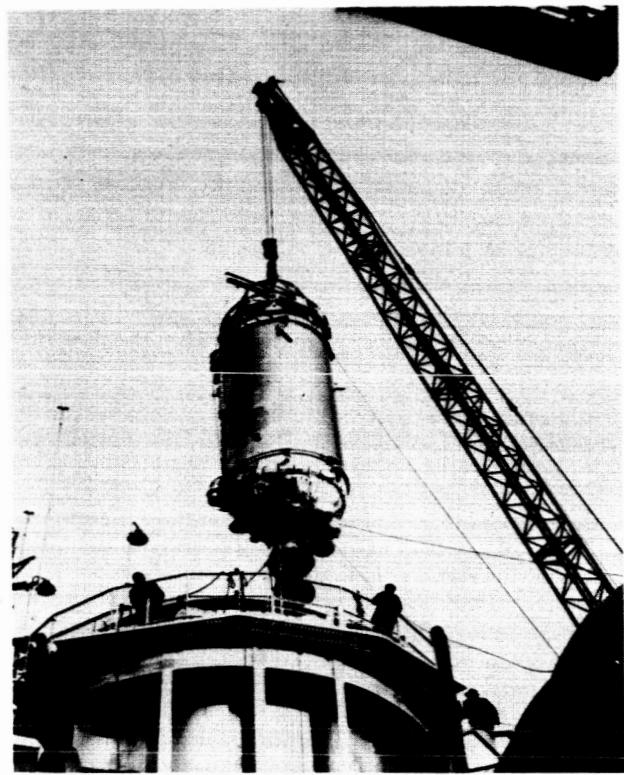
Figure 4

VIEW FROM BOTTOM AS CENTAUR IS LOWERED INTO SSC

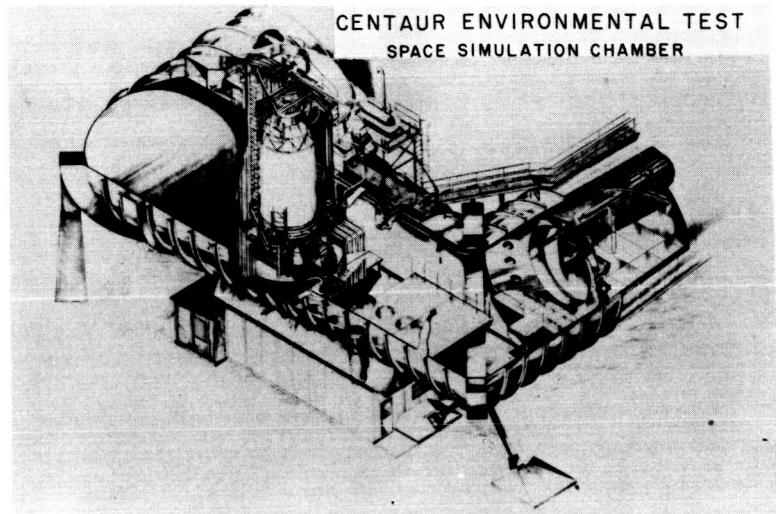
Figure 6 is a pictorial view of the modified chamber used for space simulation with the Centaur test vehicle installed. A liquid-nitrogen cold baffle, tailored to the Centaur test vehicle and consisting of an assembly of copper finned tubes has been installed. It is approximately 20 feet in diameter and 42 feet high. The thermal syphon system is utilized to maintain a full baffle, with three 7000-gallon Dewars supplying liquid nitrogen to the system.

CENTAUR VEHICLE

A solar simulator system tailored to the Centaur test vehicle consists of six separately controlled zones of quartz-iodine (500 W) lamps. There are four zones in the forward array and two in the aft. These arrays provide approximately 60 percent open area between the vehicle and the cold baffle and are designed to approximate a collimated light source.

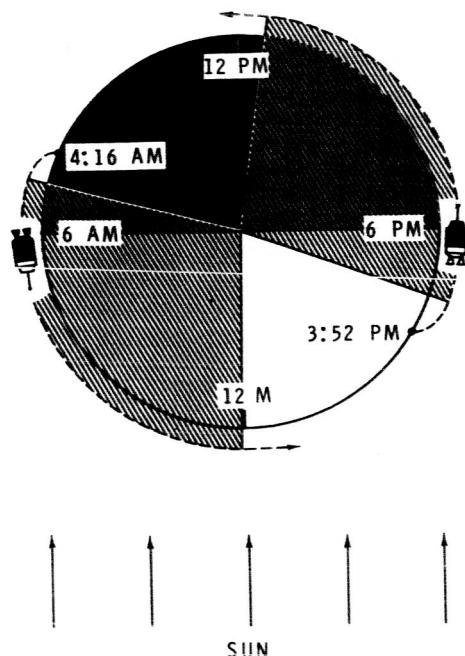
Generally, the program requires the investigation of the performance of the systems and components of a parking-orbit Centaur vehicle during that period of time starting with separation from the Atlas booster. Of particular interest are the extremes in environment that could be encountered. Figure 8 shows some extreme (temperaturewise) trajectories that could be encountered during the next flight of a Centaur two-burn vehicle depending on which launch window is met. If the vehicle is launched during the window for November 16, 1965, the trajectory would be as shown and the forward equipment would receive practically no solar heating. If it is launched during the November 4, 1965, window, the forward equipment would receive maximum solar heating. Similar trajectories exist with respect to the propulsion and mechanical systems mounted at the rear of the vehicle.

AC-4 FLIGHT PROFILE

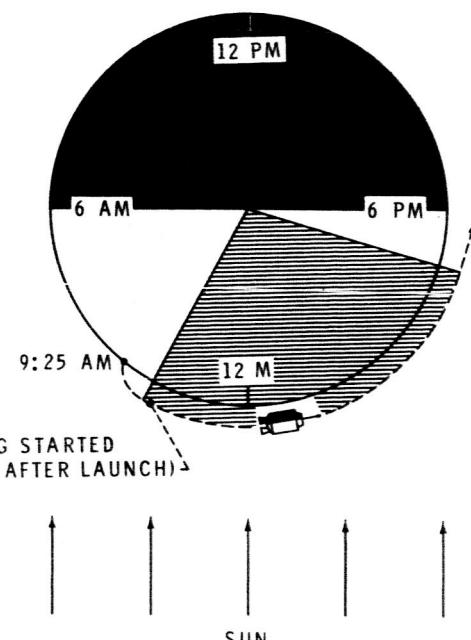
Figure 9

The trajectory that was actually attempted on the Atlas-Centaur 4 vehicle is shown in figure 9. Unfortunately the vehicle started tumbling about 10 minutes after it was separated from the Atlas and therefore the thermal data after that point in time are not too meaningful. A comparison of the flight and vacuum (SSC) rate-gyro-cover temperatures for the first 10 minutes of Centaur flight is shown in figure 10. Although the starting temperatures were different, the similarity in trends indicates that a reasonable simulation was obtained. Although only preliminary tests have been made to date, a variety of functional difficulties have been uncovered. These are listed in table I. Thus full-scale environmental test chambers appear to be a valuable tool in the development of flight hardware.

TEMPERATURE COMPARISON, RATE-GYRO-UNIT COVER TEMPERATURE

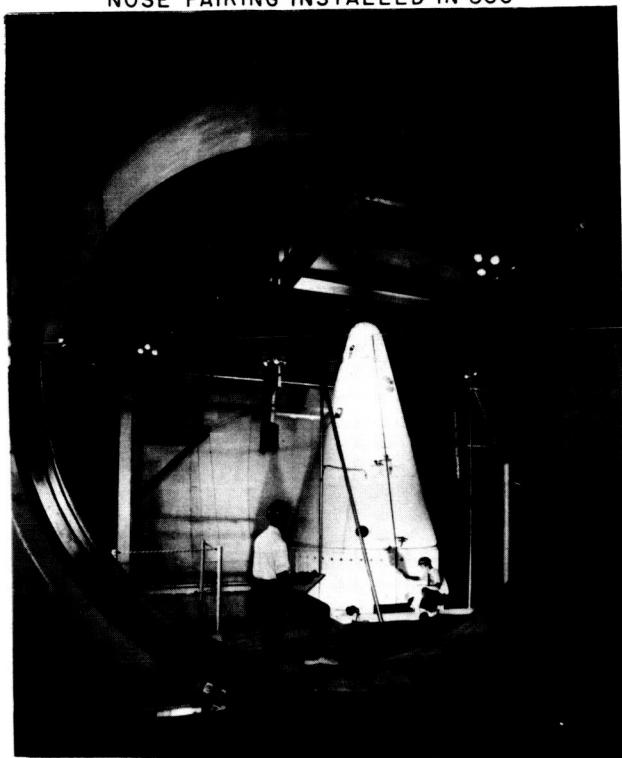
Figure 11

A standard flight type fiberglass-honeycomb nose fairing was used for all tests. A photograph of it installed in the facility is shown in figure 11. The salient features of the nose fairing are that it consists of two halves held together by explosive bolts, which are fired just prior to separation, and that the separation force is provided by two high-pressure-gas thruster bottles installed in the upper end. It was felt that the pressure forces resulting from discharge of the bottles and the resulting nose fairing dynamics could have contributed to the anomaly detected during the Atlas-Centaur 3 flight.

NOSE FAIRING JETTISON SETUP IN S S C

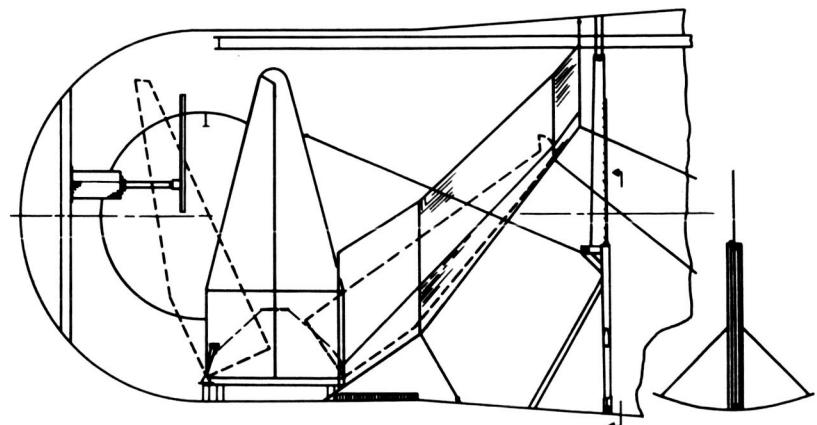
Figure 12

The installation of the full-scale Centaur nose fairing for the Atlas-Centaur 4 flight qualification tests conducted in SSC is illustrated in figure 12, which presents a diagrammatic sketch showing the relation between the nose fairing and the stopper on the left side and the catcher net on the right. Briefly, the stopper on the left in conjunction with a

NOSE FAIRING AFTER JETTISON IN S S C

facility-type hinge permitted about 20° rotation of the left fairing, whereas the net on the right permitted about 50° rotation and allowed the fairing to jettison freely in a manner similar to that which occurs in flight (fig. 13). Space limitations (the proximity of the Centaur vehicle) prevented the net from being installed and thus permitting a greater degree of freedom.

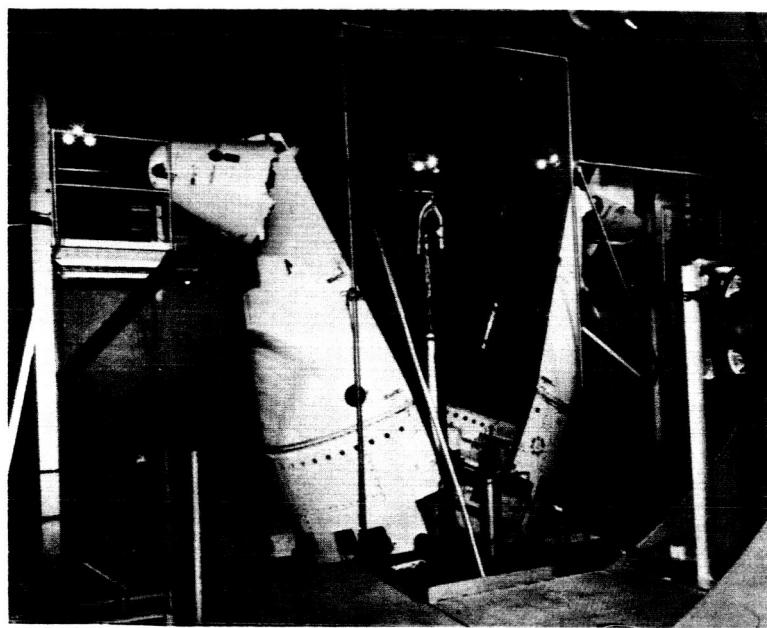
Figure 14

The answer to this problem was eventually obtained by comparing the chamber data with flight data; however, prior to flight the best that could be done was to compare the sea-level test with the vacuum-chamber test and observe that a considerable difference existed. This difference is illustrated in figure 14, which shows the hardware after the first firing in a vacuum; this compares with no damage for the sea-level firings. A comparison of the nose fairing trajectories obtained at sea level and in a vacuum (Atlas-Centaur 3) is shown in figure 15. The trajectory in a vacuum is much faster than at sea level and accounts for the damage experienced.

COMPARISON OF CENTAUR-SURVEYOR NOSE FAIRING TRAJECTORIES

Inasmuch as no serious damage occurred when the fairing followed the trajectory labeled "AC-3 Sea Level," it was decided to adjust the bottle pressure and throat size in order to obtain a similar trajectory for flight. When this was done, the trajectory labeled "AC-4 vacuum" was obtained in the chamber. A comparison of this trajectory with Atlas-Centaur 4 flight data indicates good agreement.

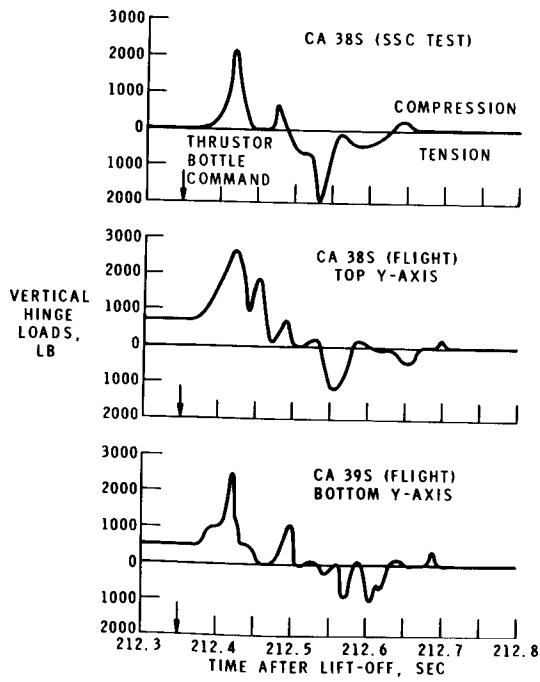
Figure 16

A further comparison of flight and vacuum chamber dynamic measurements is presented in figure 16, which shows nose fairing hinge loads during jettison as measured in the vacuum chamber and as measured during Atlas-Centaur 4 flight. Again, relatively good agreement was obtained. Comparison of pressures measured in the fairing thruster bottle compartment during the Atlas-Centaur 4 flight and in the vacuum chamber also agreed well with a peak pressure of 9.2 pounds per square inch absolute measured in flight and 8 pounds per square inch absolute in the vacuum chamber.
